# ROBINSON CREEK RESTORATION PLAN

December 31, 2024

Oregon Natural Desert Association

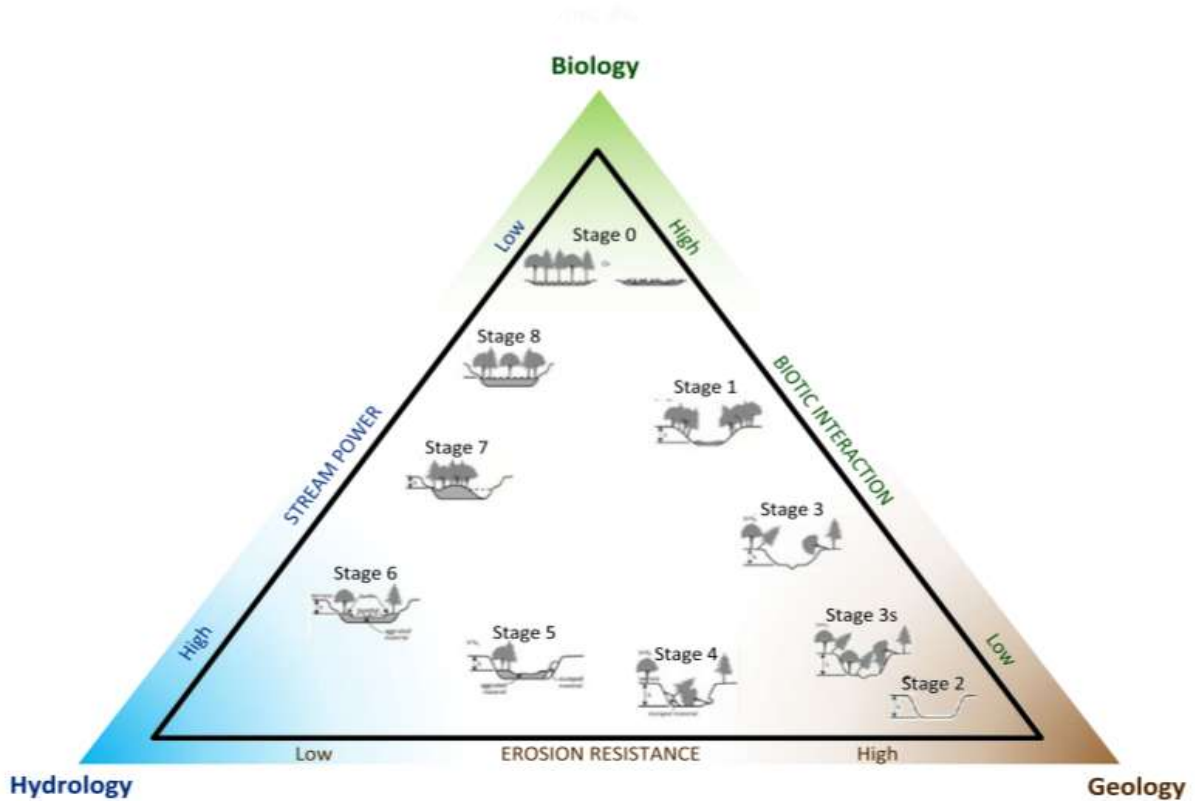
**Figure 6. Stream Evolution Triangle**

Castro and Thorne’s Stream Evolution Triangle (Figure 6, Castro and Thorne 2019) depicts how the state, or current condition, of a stream is influenced and controlled by three main factors: Biology (typically thought of as “vegetation”, but includes influence of everything from mussel beds to beavers),

Hydrology (the interaction of water cycles with the landscape), and Geology. Stream state or condition can vary depending on the weighting of the three controlling factors within the Stream Evolution Triangle (SET), with example of real-world stream conditions represented by the diagrams of stages of degradation (or recovery) within the triangle. The lower zone of the SET represents the least beneficial habitat that is in the least healthy, most degraded state.

In the case of Robinson Creek, the stream is missing key biological controls (i.e., beaver and robust riparian vegetation), has limited flows, and is confined by geologic factors, with the stream channel reduced to cobbles and exposed bedrock in many places. Without intervention, the stream state will likely remain confined to the lower portion of the SET.

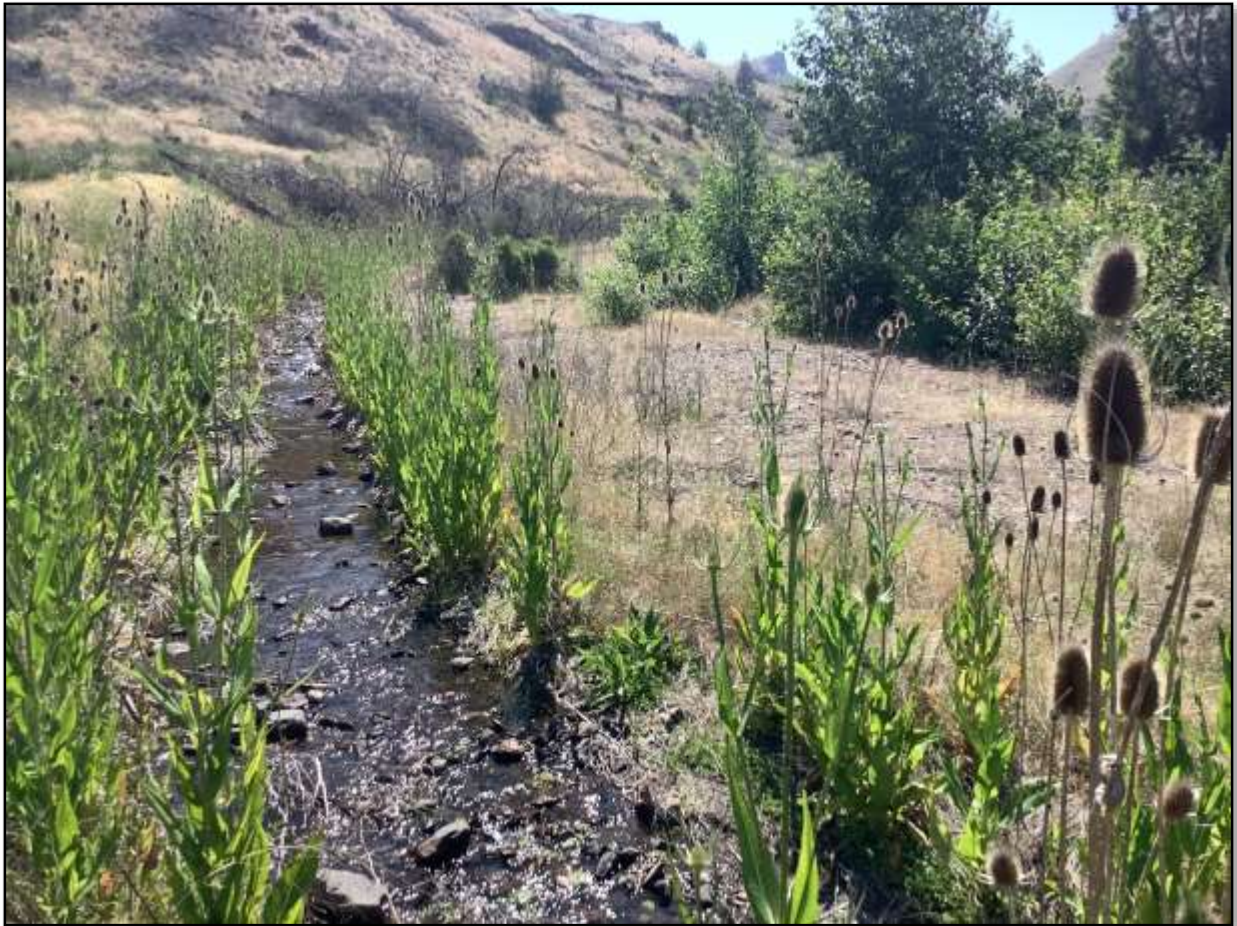
Looking upstream from the bottom end of the reach. Notice vegetation band planted in area of former creek location.

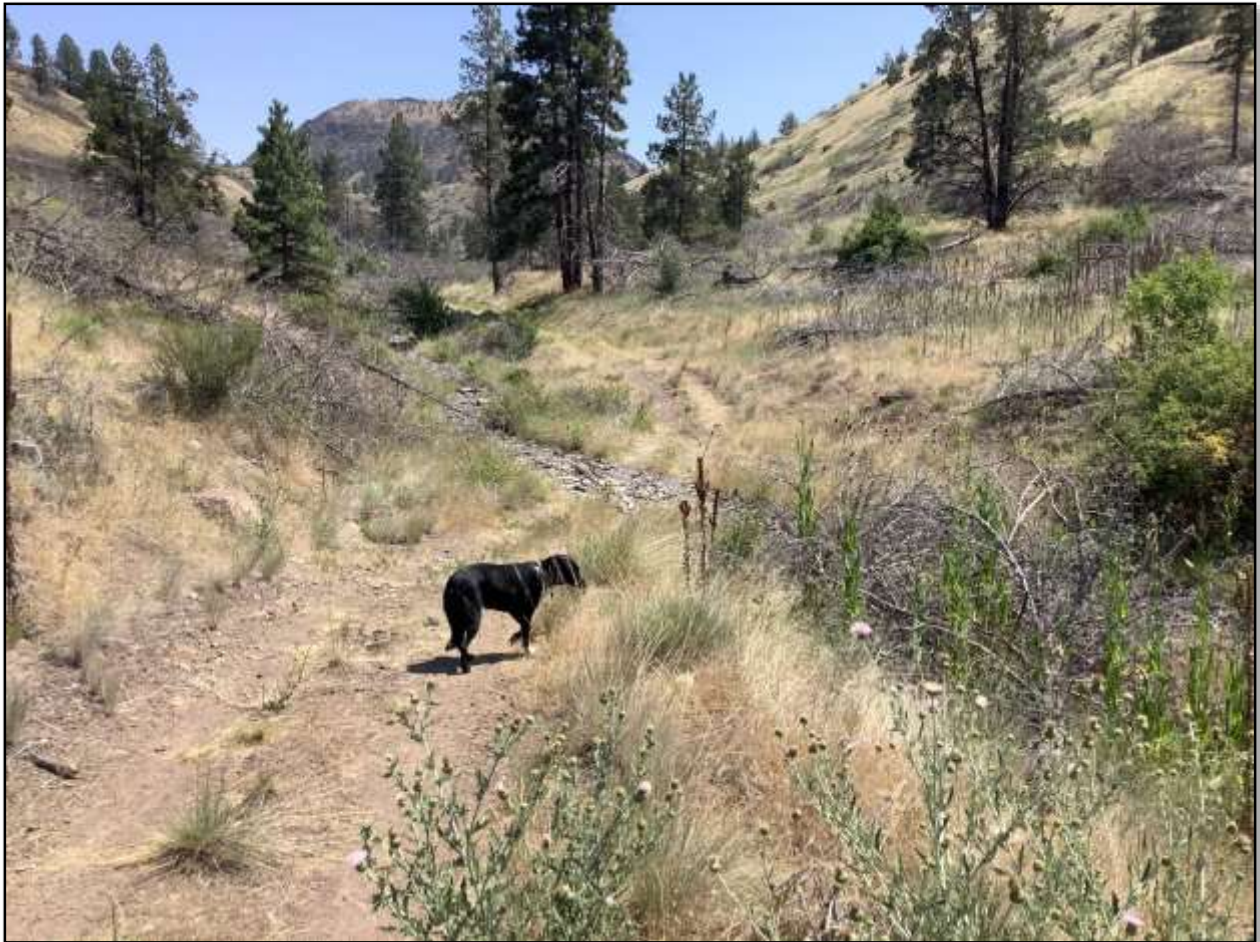
Looking upstream across the crossing that defines the downstream end of the reach.

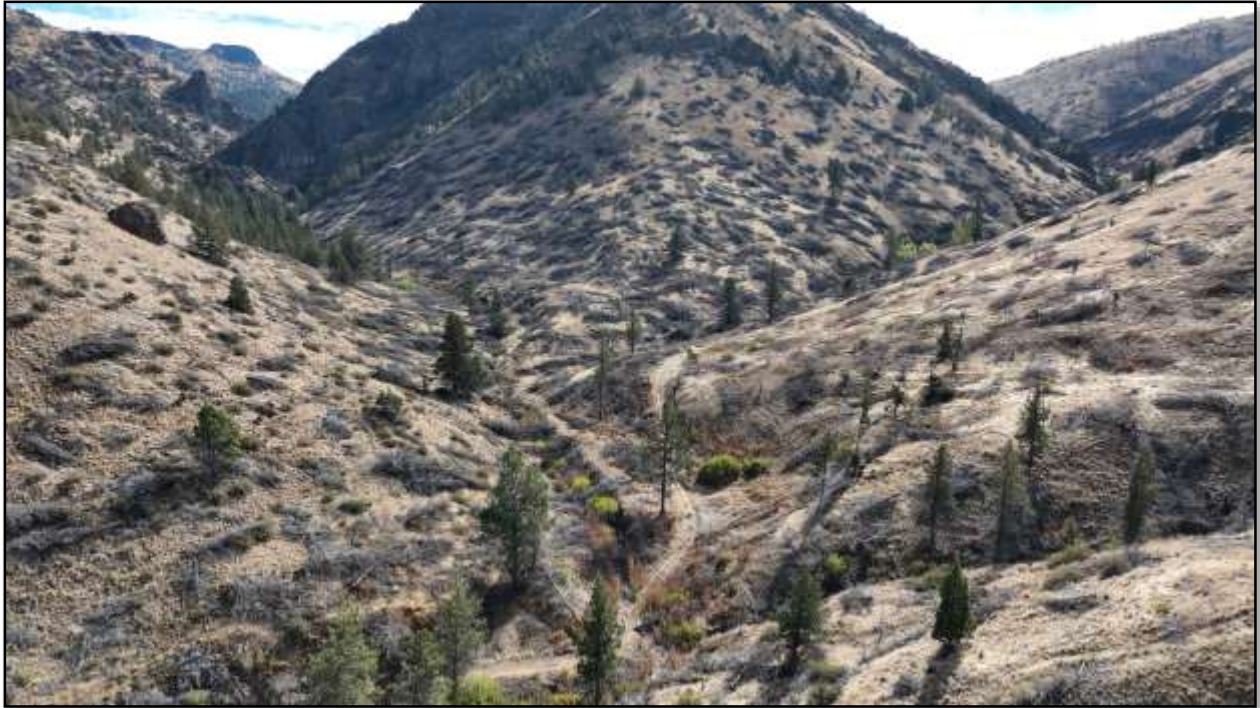
Looking upstream from above the lower crossing that delineates the lower end of the reach. Little Pine on left, Robinson on right.

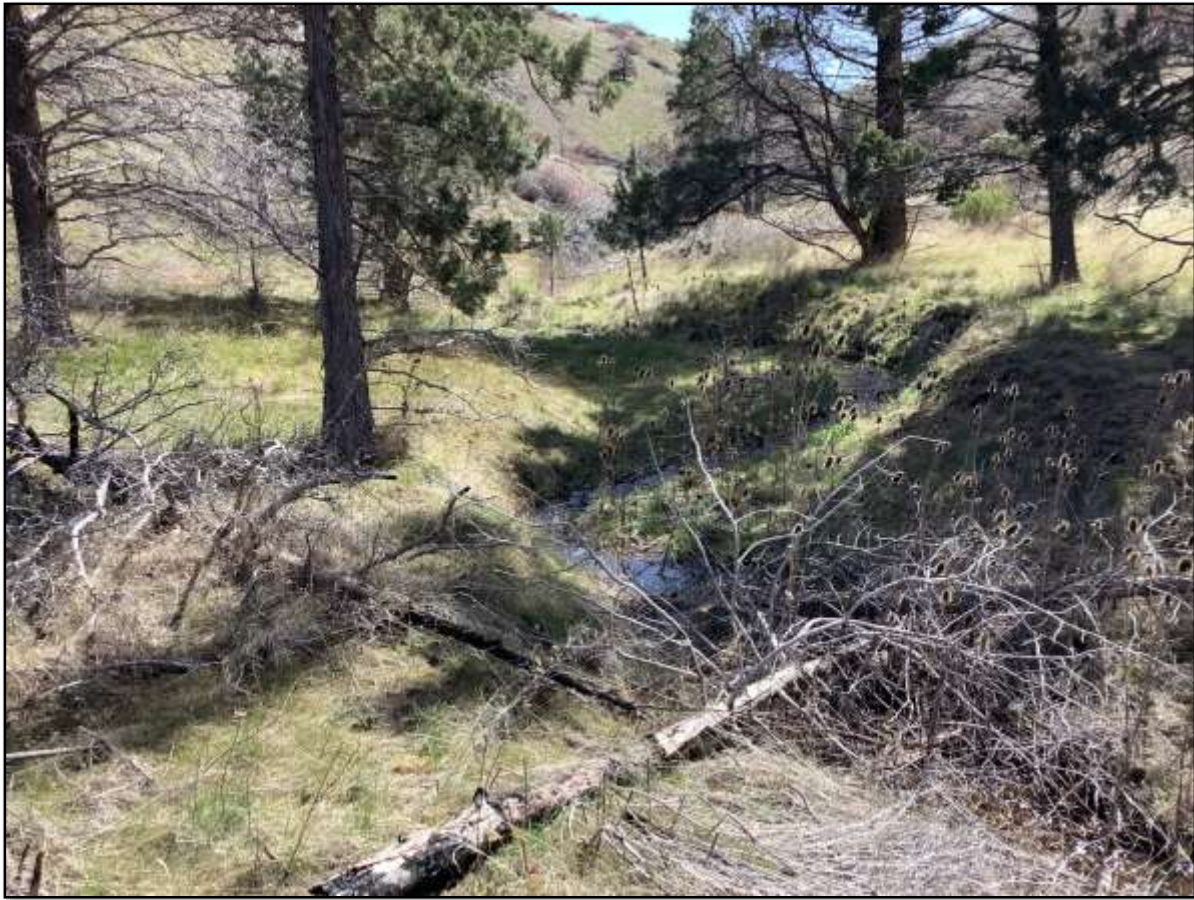
Accessible floodplains, and uncut juniper stands within the lower half of Upper Robinson Reach F.
